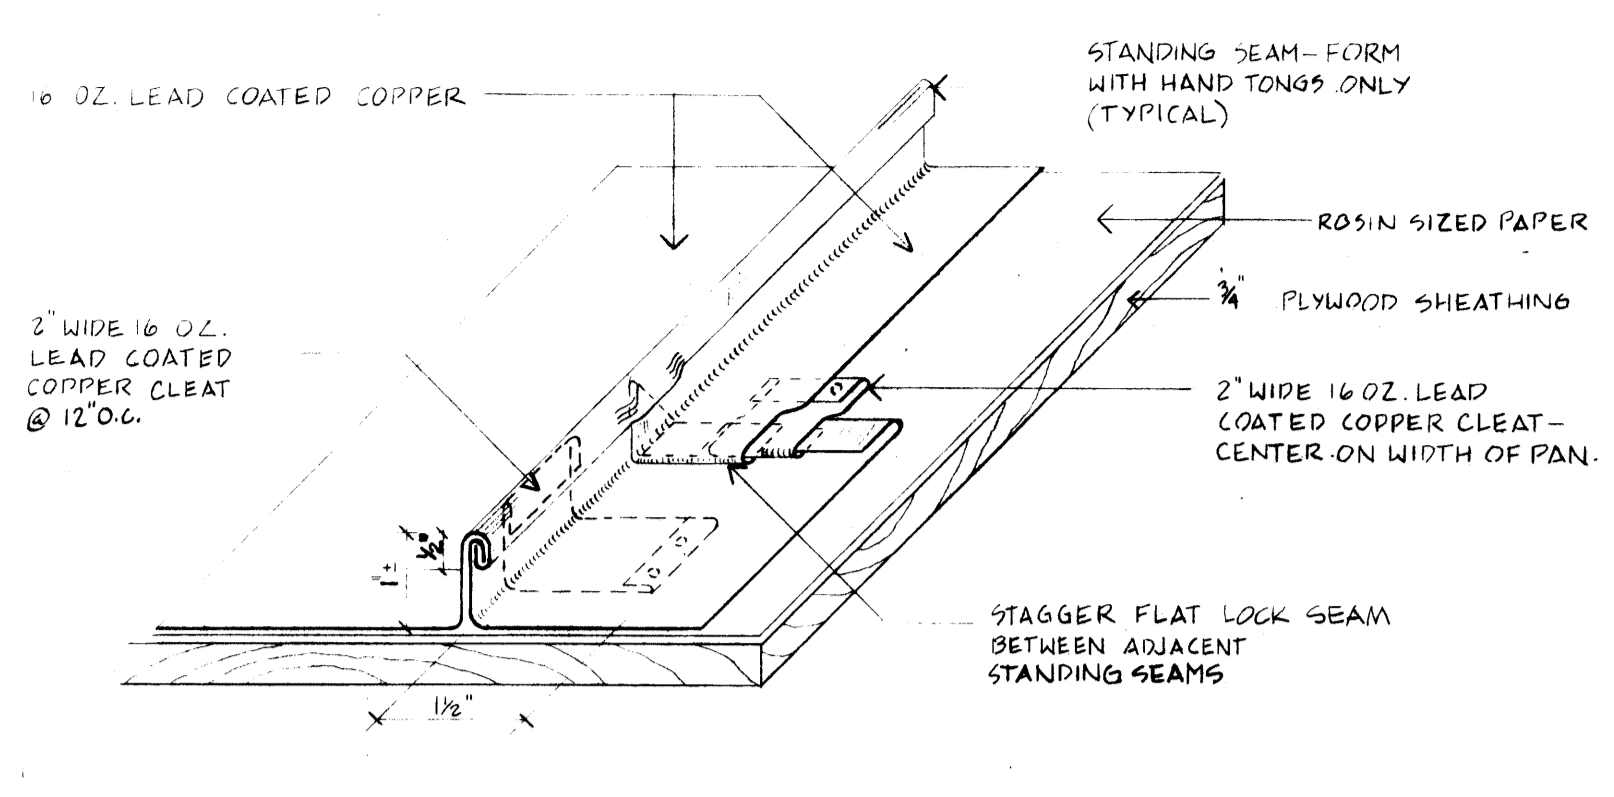
1 TYPICAL BAY - STANDING SEAM DETAIL
NOT TO SCALE

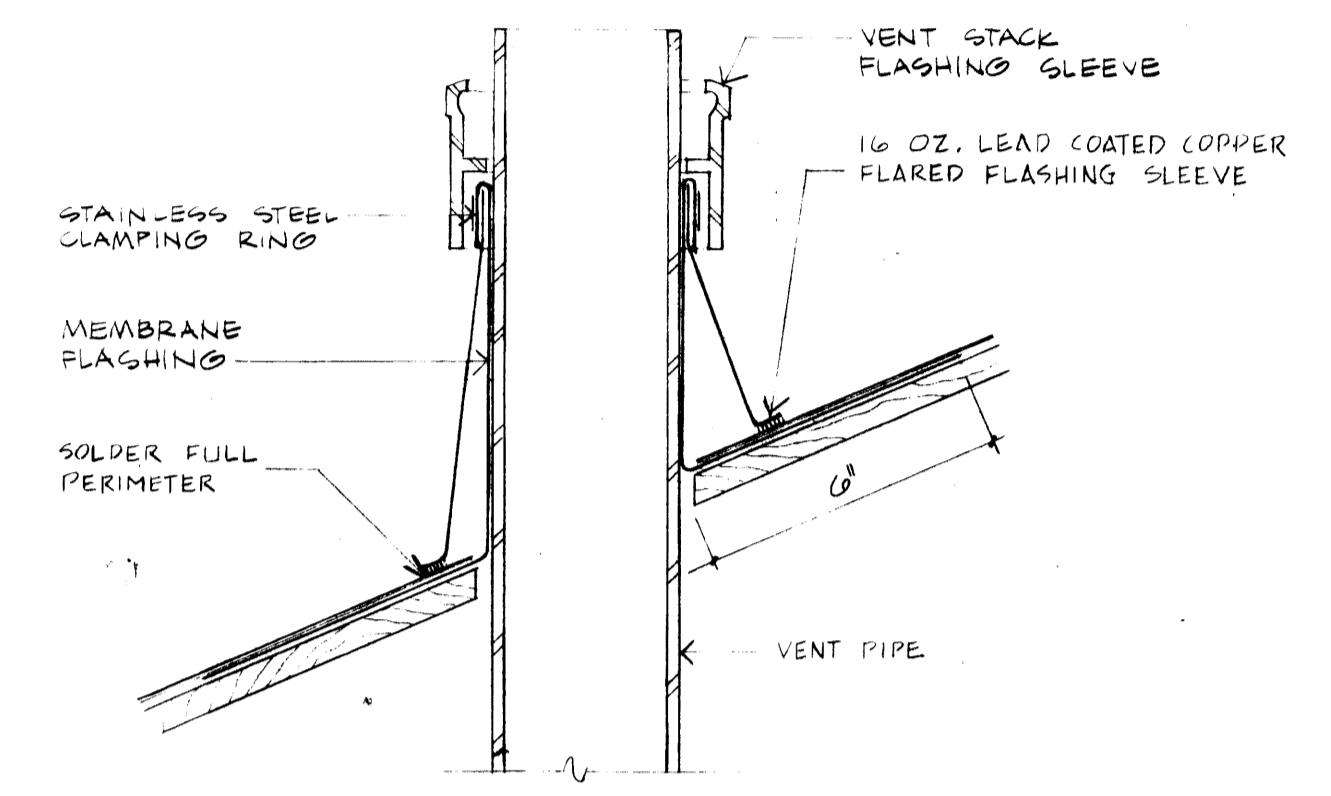
5 VENT PIPE FLASHING
NOT TO SCALE
